PROJECT OVERVIEW

MULTI STAGE VIT SUMP PUMP

We received the Multi Stage VIT pump for rebuild. The pump was disassembled and inspected here at our facility.

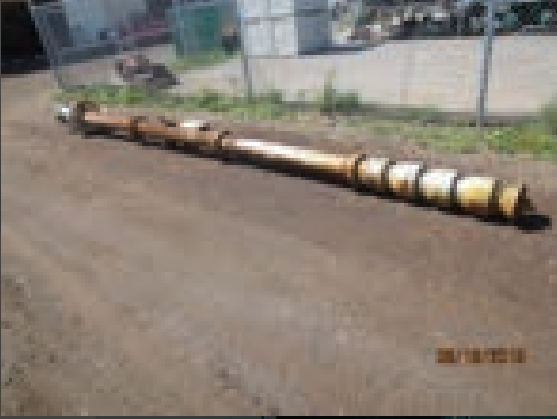
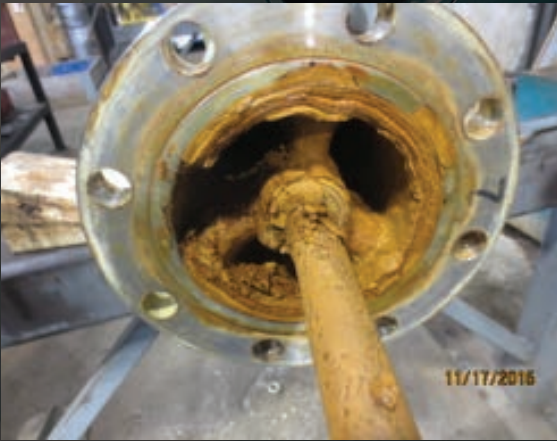
Upon disassembly and inspection of the pump, the following faults were found:

- Spider bearings worn
- Marine bearings worn
- Pump shafts worn to .005" undersized
- Shaft couplings seized and will need to be replaced
- Stuffing box bushing worn
- Impeller collet worn
